# Test Report 95XS0294-00

## Haztec International Limited

Vehicle Tests (250 km/h)  
with warning lamps  
installed on vehicle roof  
on  
8 December 2009

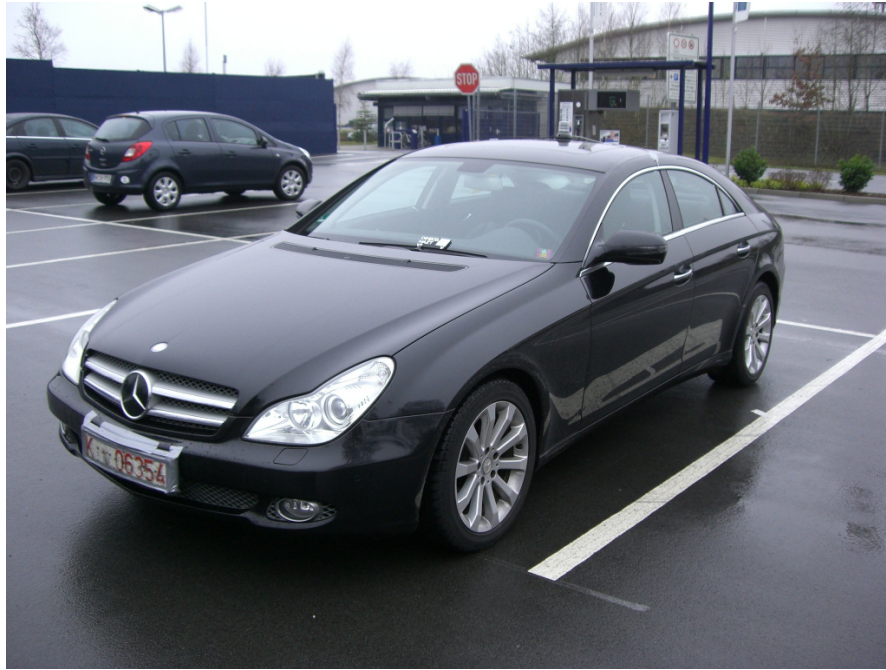
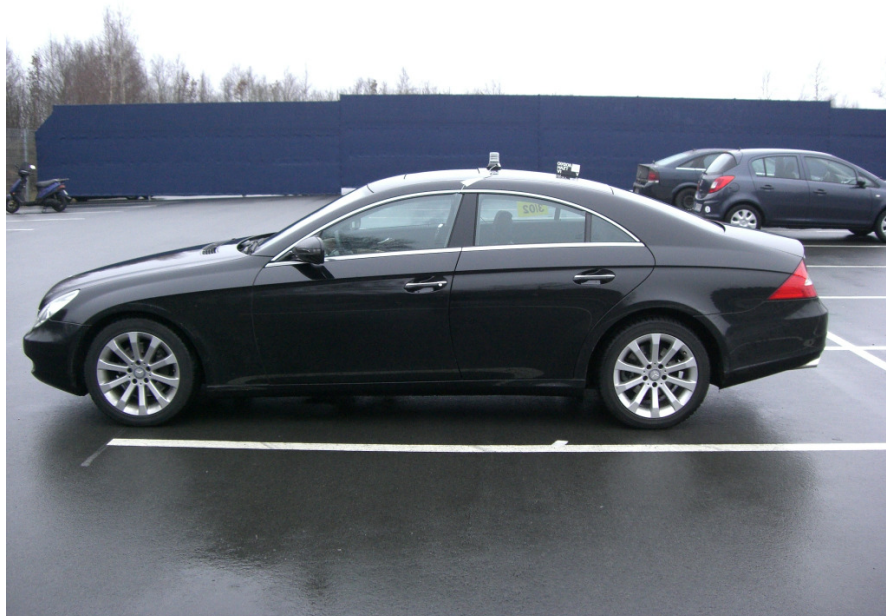
**Photograph – Test vehicle**

| <b>Test vehicle</b> | Mercedes Benz CLS, Type 219 |

The test samples were installed behind the sun roof in the centre line of the vehicle and secured by wires. The roof panel was in a dry condition.

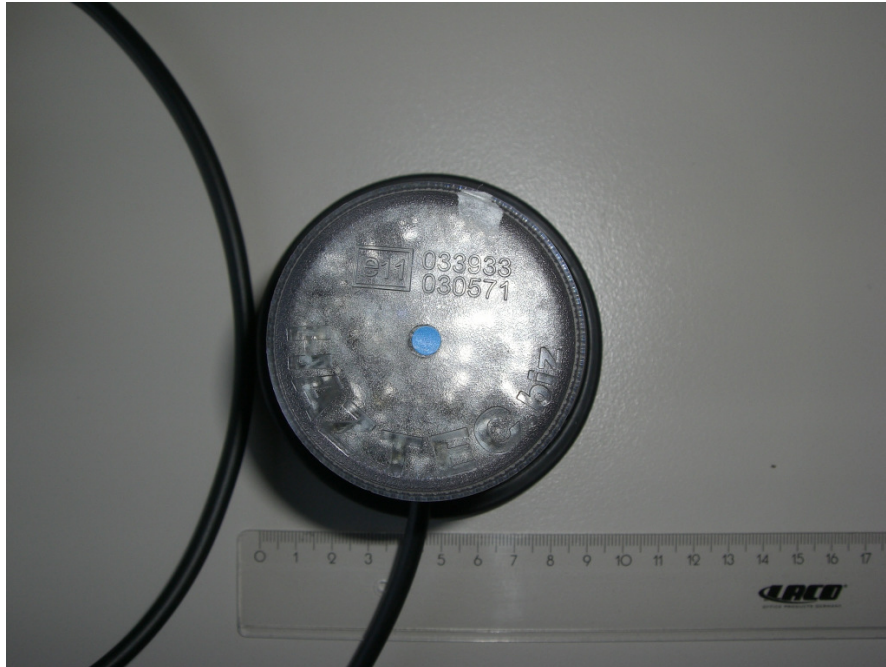
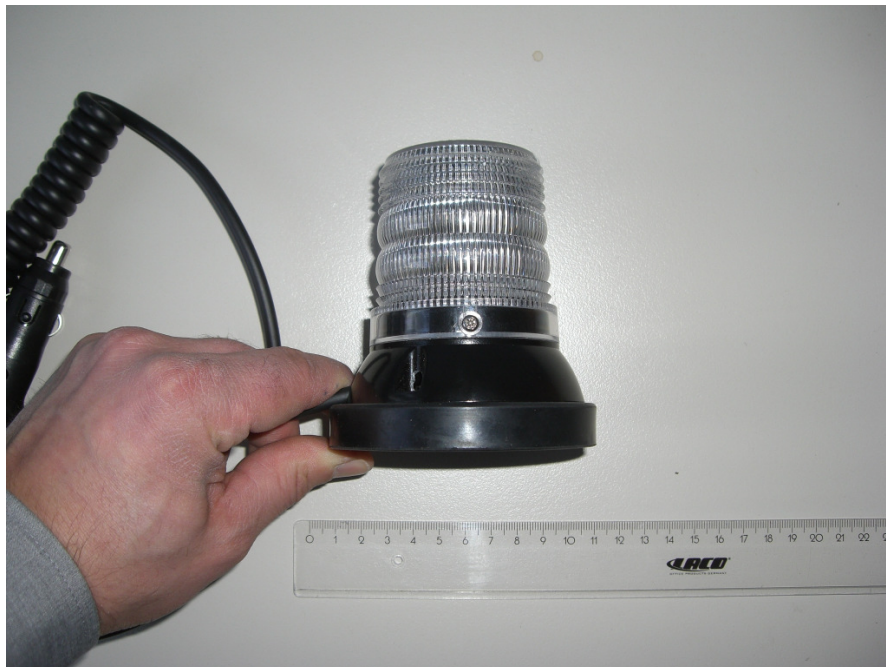
Photograph – Test object 09 058.4 178

| <b>Test object no. / Type / mass / Fixation to roof</b> | 09 058.4 178 / Impact C Beacon 3-3341-M / 0,7 kg / 1 magnetic fixation base<br>09 058.4 179 / Impact LP Beacon 3-3541 / 1 kg / 1 magnetic fixation base<br>09 058.4 180 / Mini bar 4-9942 / 2,8 kg / 4 magnetic fixation bases<br>09 058.4 181 / XP mini Lightbar 90-22000 / 3,35 kg / 4 magnetic fixation bases |

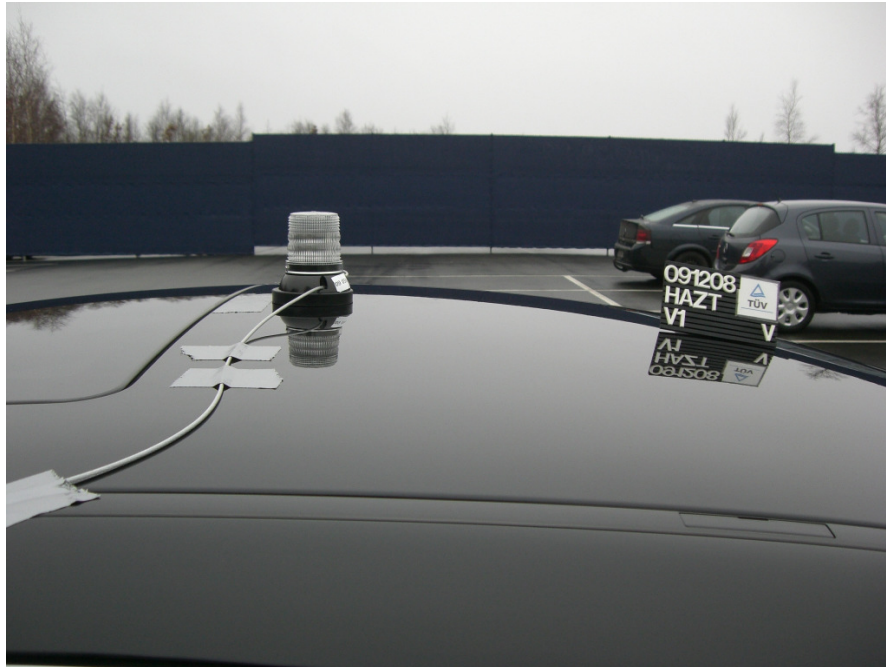
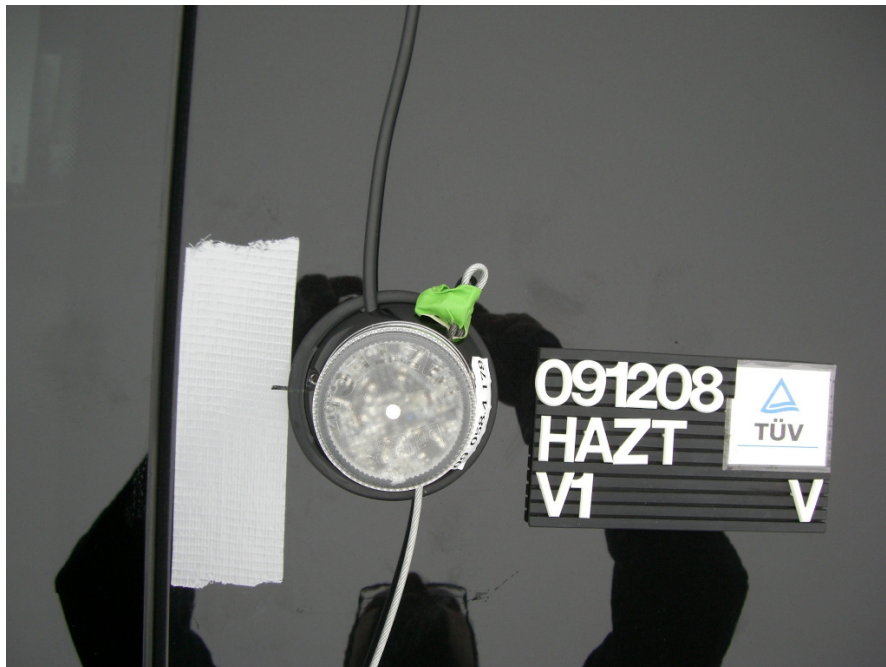
Photograph – pre Test 1

The initial positions of the magnetic fixation base(s) of the warning lamps were marked.

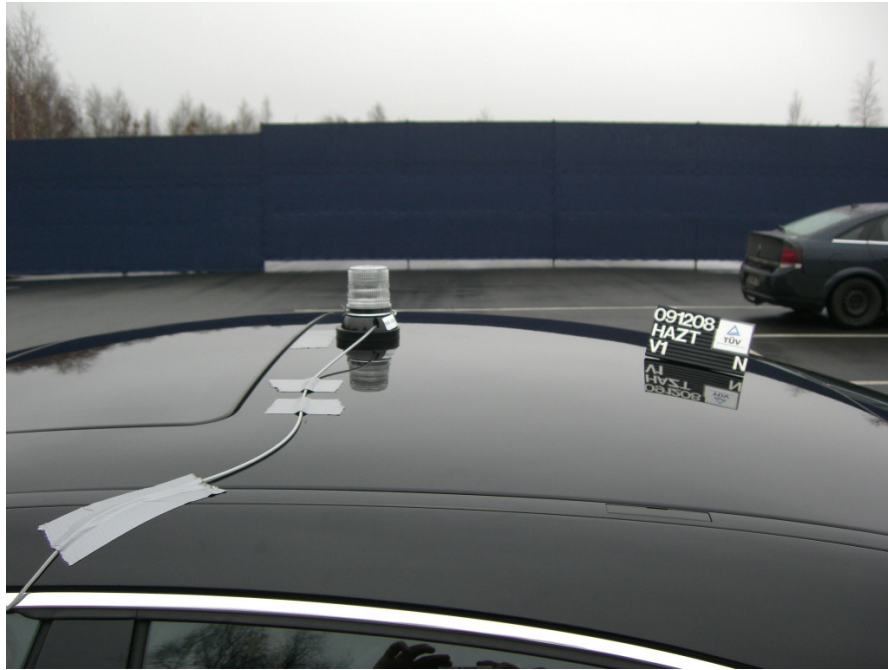
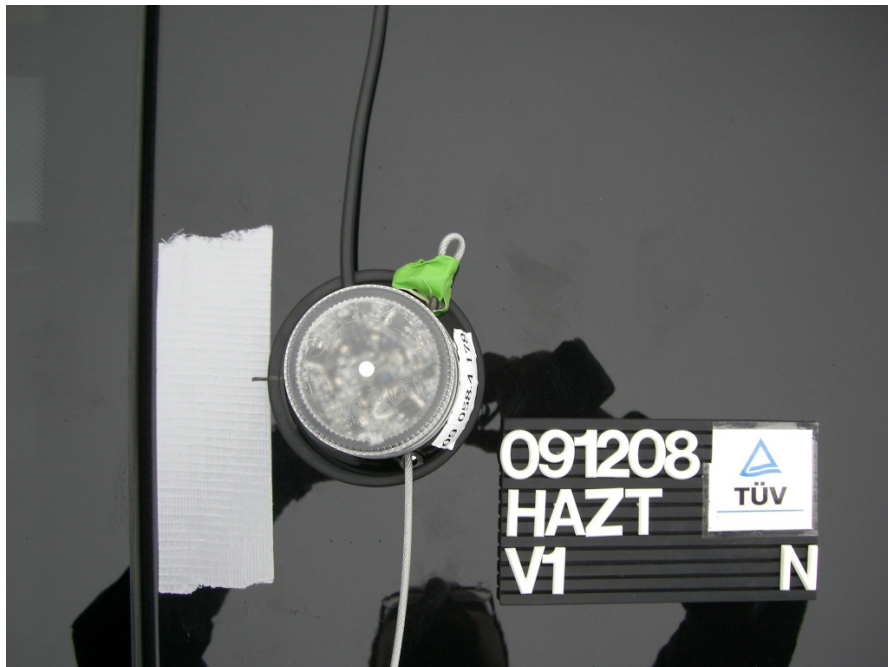
Photograph – after Test 1

| Test No. | Test object no. | Test Result | Remarks |
|---|---|---|---|
| 1 | 09 058.4 178 | Positive, no displacement of warning lamp | -- |

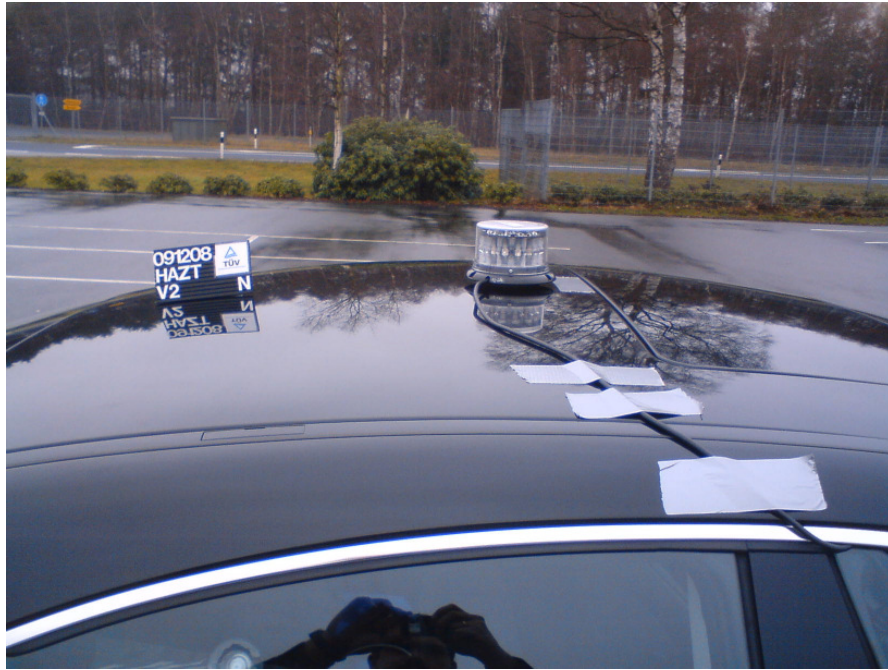
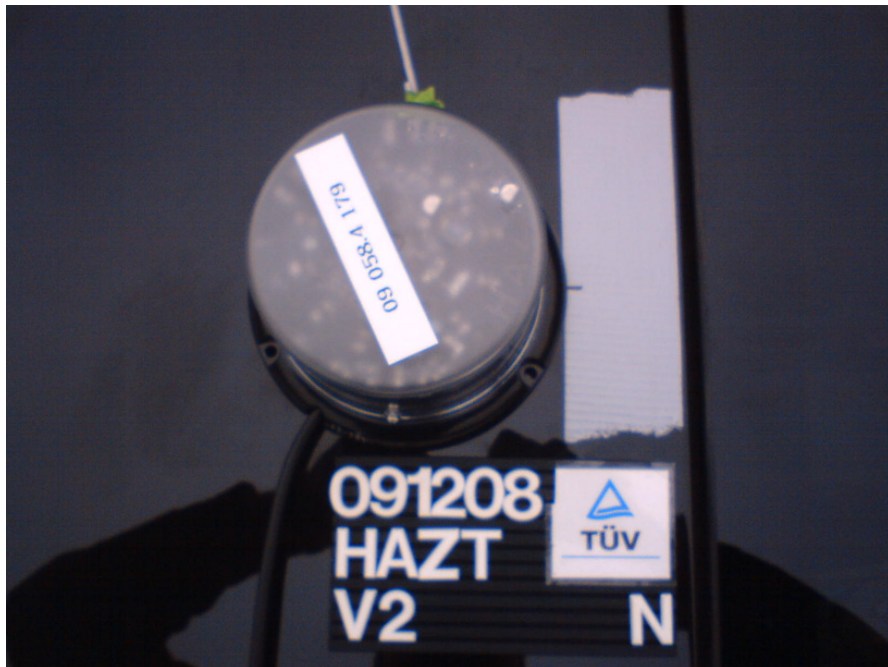
Photograph – after Test 2

| Test No. | Test object no. | Test Result | Remarks |
|---|---|---|---|
| 2 | 09 058.4 179 | Positive, no displacement of warning lamp | -- |

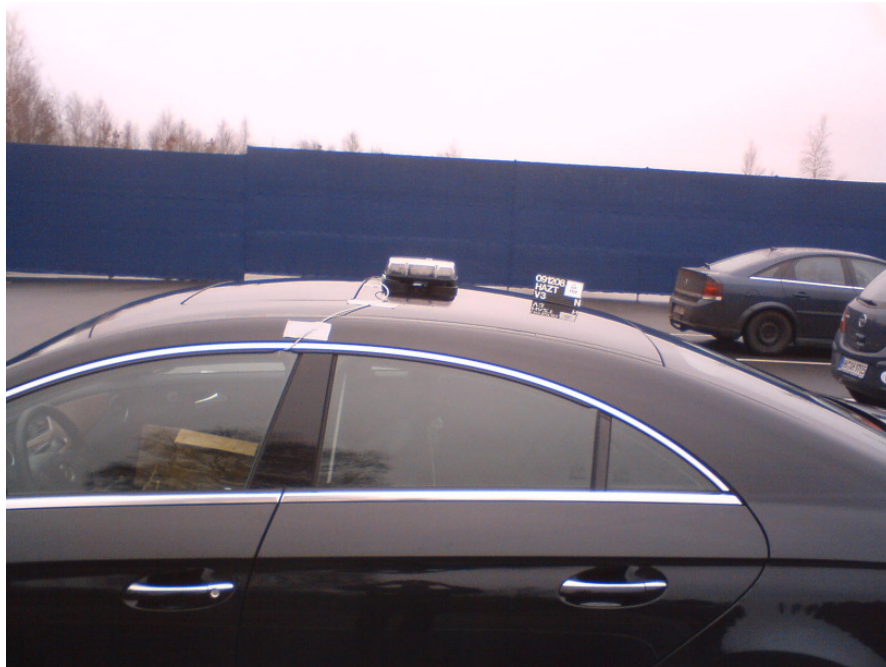
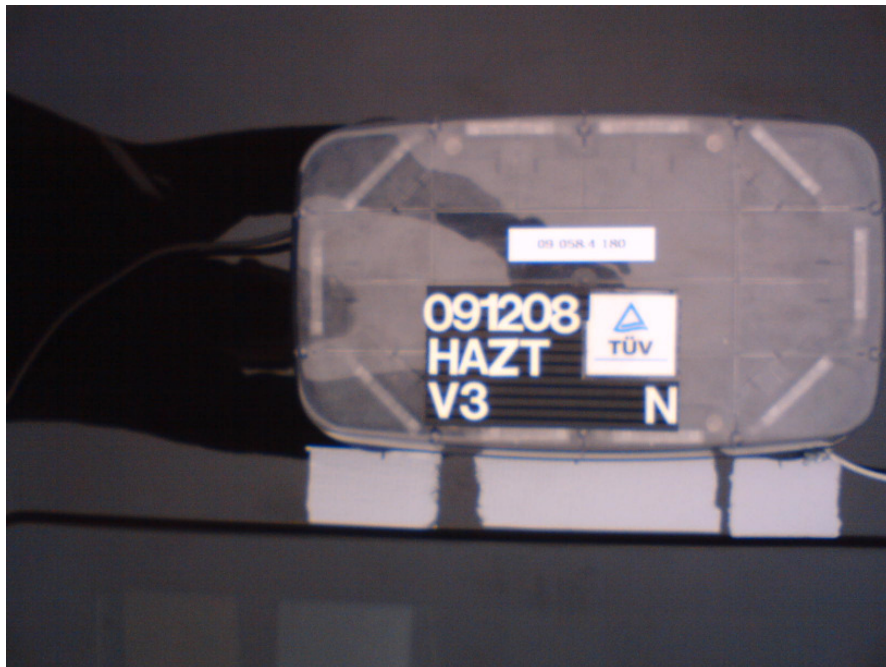
**Photograph – after Test 3**

| Test No. | Test object no. | Test Result | Remarks |
|---|---|---|---|
| 3 | 09 058.4 180 | Positive, no displacement of warning lamp | -- |

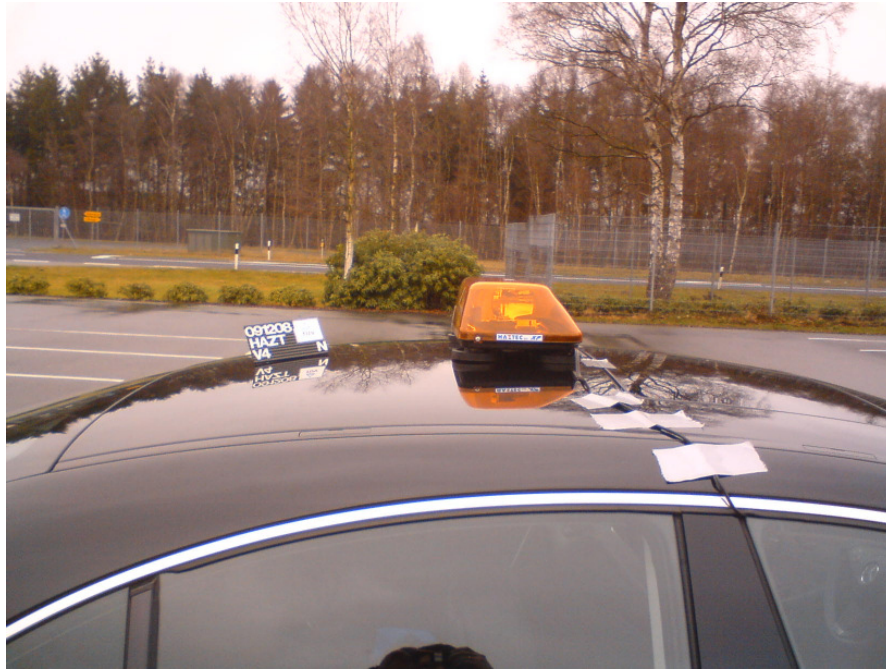
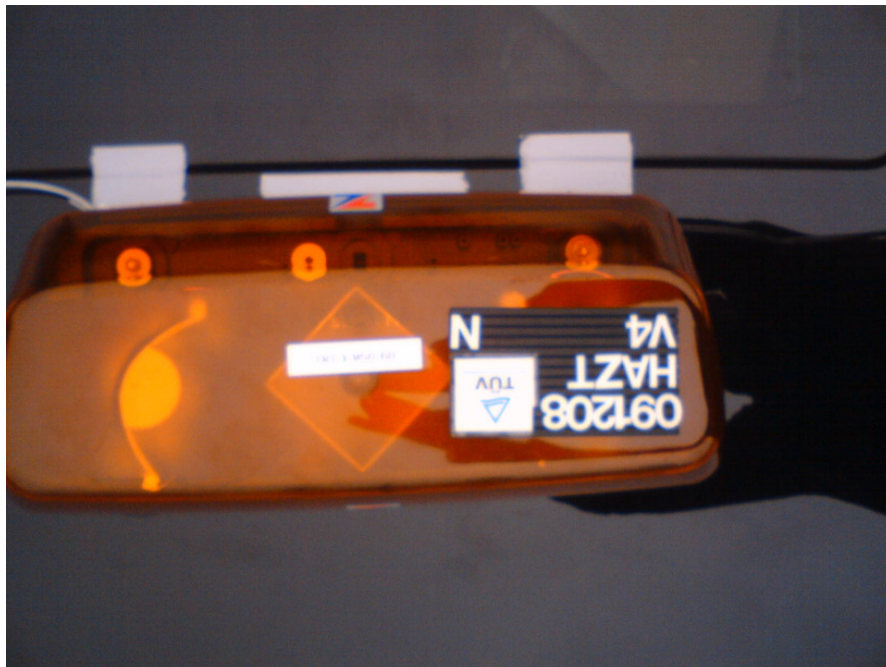
Photograph – after Test 4

| Test No. | Test object no. | Test Result | Remarks |
|---|---|---|---|
| 4 | 09 058.4 181 | Positive, no displacement of warning lamp | Due to curvature of the vehicle roof the rear magnetic fixation bases have no full contact to the roof panel. |
